*Action required – blocked surface water drains – Kembhill Park foot path on river side of estate which runs between No 5 and No 87.*

Jim Buchan – Secretary of the KPFG

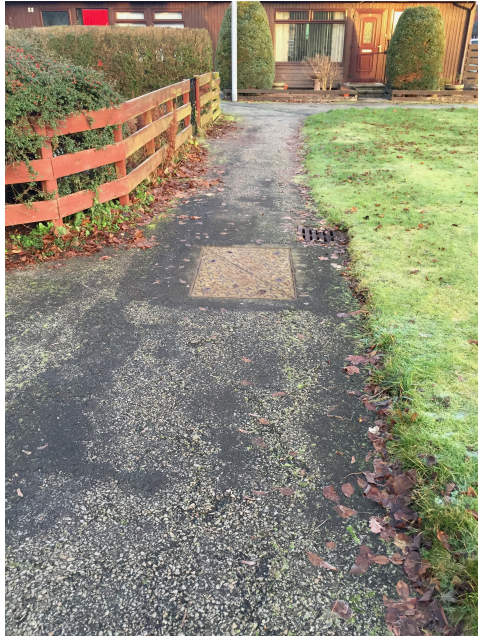
Photo 1 – adjacent to No 23

The grills for many of these drains are over grown with grass and covered with other debris. Residents also report that the path floods during heavy rain due to the drains being unable to clear accumulated surface water.

Please can these surface water drains be maintained routinely (debris and vegetation cleared) as necessary to return them to full operational status.

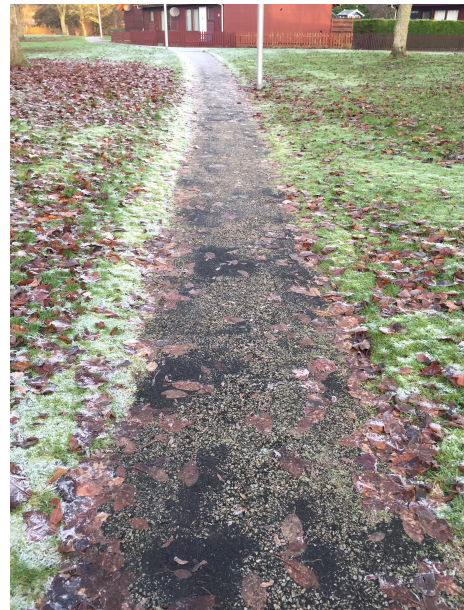
Shows the vegetation over growing over the path.

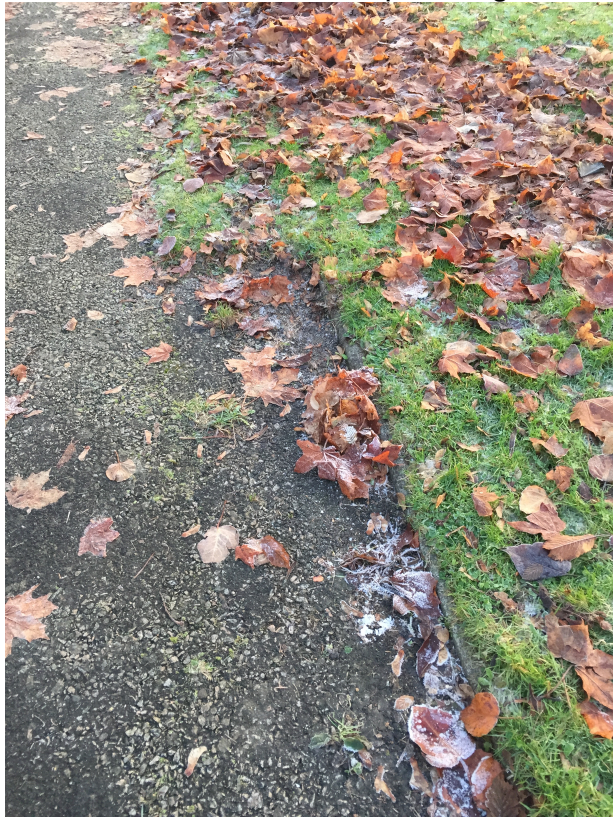
Show where the overgrown vegetation has been removed back to the path edge

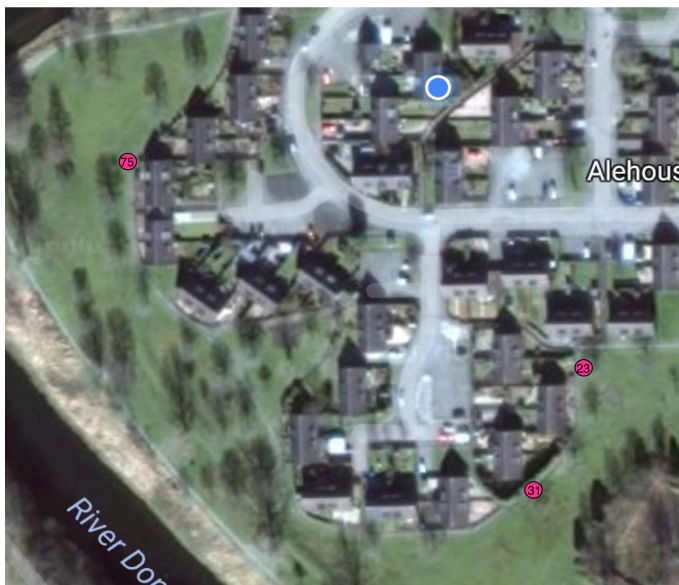
## Map showing position of visible drains.

Shows Currently visible Drains on ash felt path  
visual survey on 26th November 2016 - by Jim Buchan  
Number of adjacent house used to identify approx position

shows position  
of visible drain
